STS-107 POST LAUNCH FILM REVIEW KSC Photo/Video Analysis Team 17 January 2003

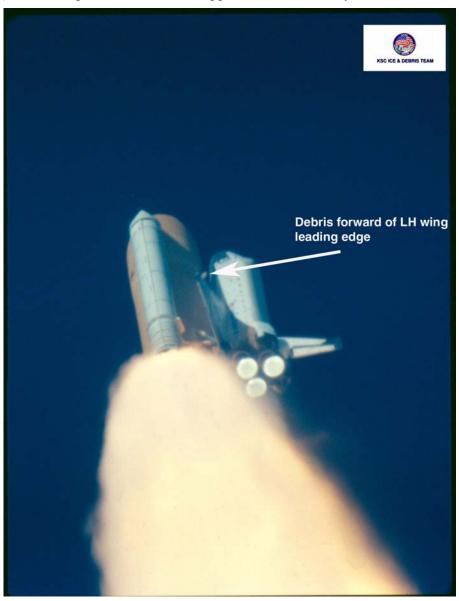
Photo 1.

1. At approximately 80-84 seconds (accurate timing off of film will be done tomorrow) after T-0 a large piece of debris is observed striking the underside (-Z) of the LH wing of the orbiter. The debris appears to originate from the area of the –Y bipod attach point on the external tank. (E-208, E-212) No damage to orbiter TPS is apparent. Further analysis will continue.
